C U L T U R A L L A N D S C A P E R E P O R T

Harry S Truman National Historic Site Independence, Missouri

APPENDIX

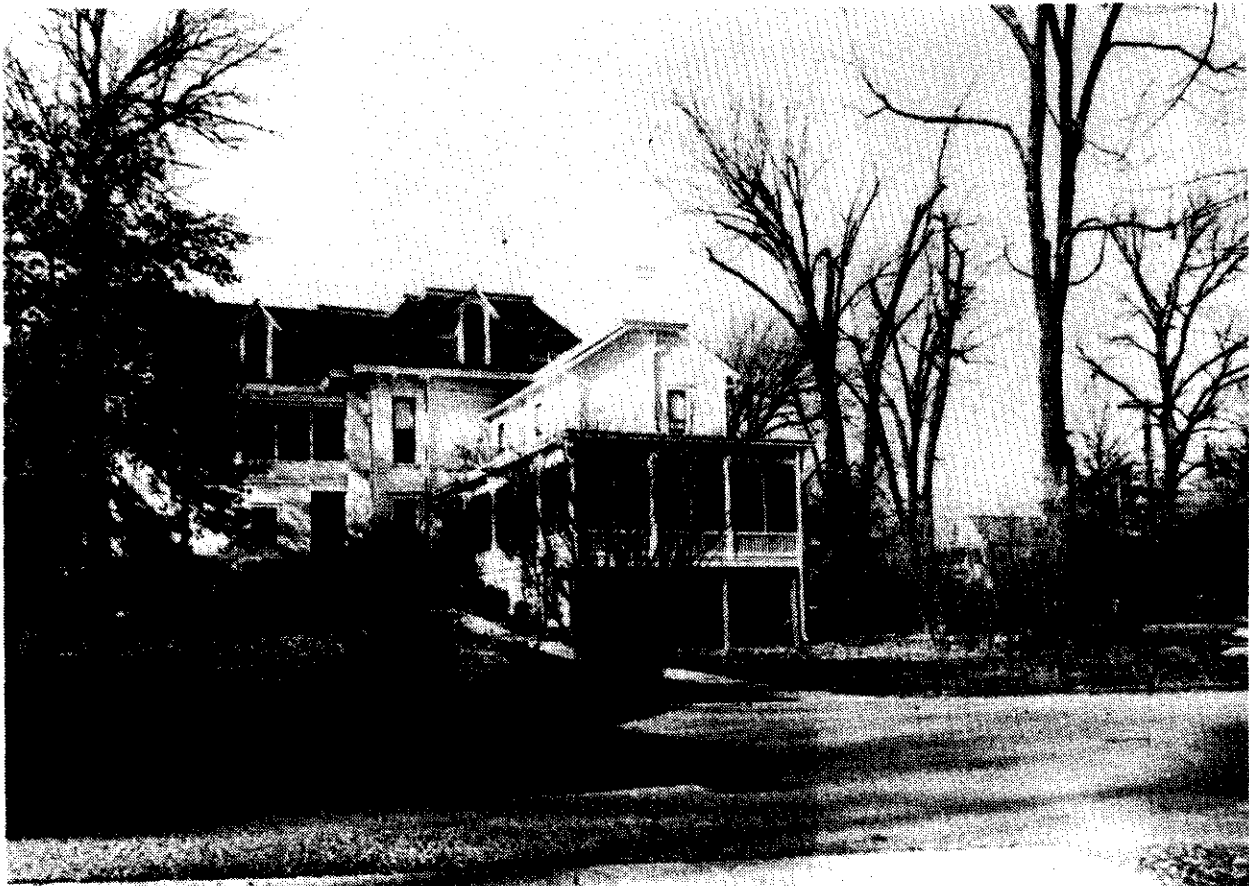
FIGURE 23

Truman home and east yard (looking northwest).

Important landscape features: paved driveway; bushes on the west side of driveway; spirea and tree in "L" of house; missing pergola marked by two trees and tall bushes; winterized rose garden; sundial and birdbath; and tall shrubbery along the Truman Road fence.

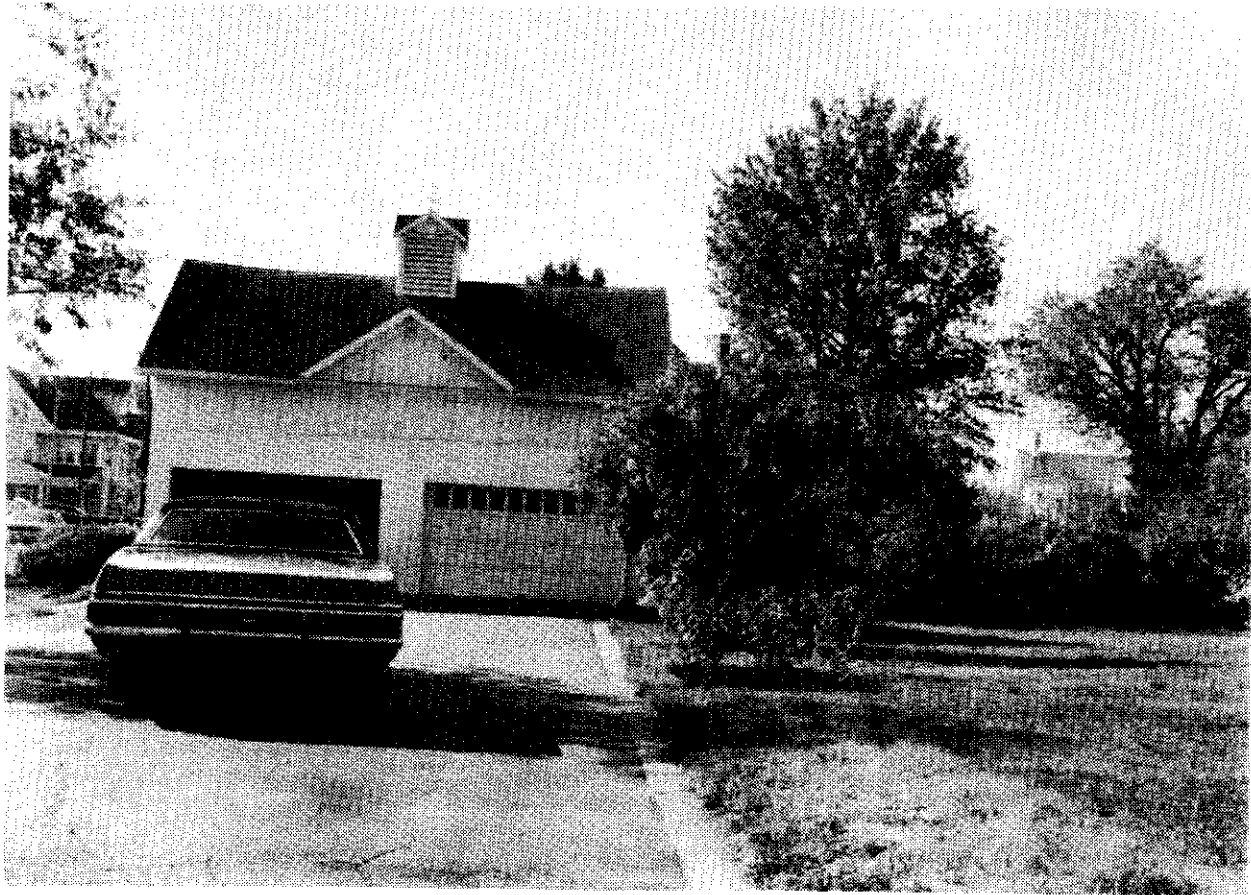
FIGURE 24

Barn and southeast yard of Truman home (looking south).

Important landscape features: driveway with concrete edging; rose garden; large shrubbery to the northeast side of the barn; and overgrown shrubbery along the south alley fence.

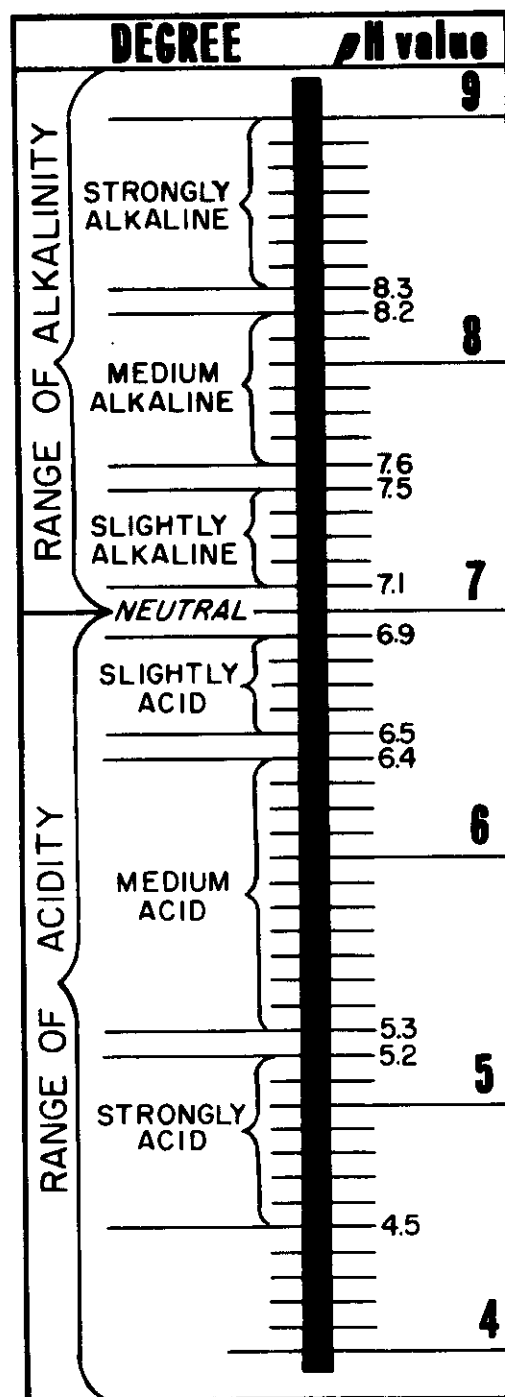
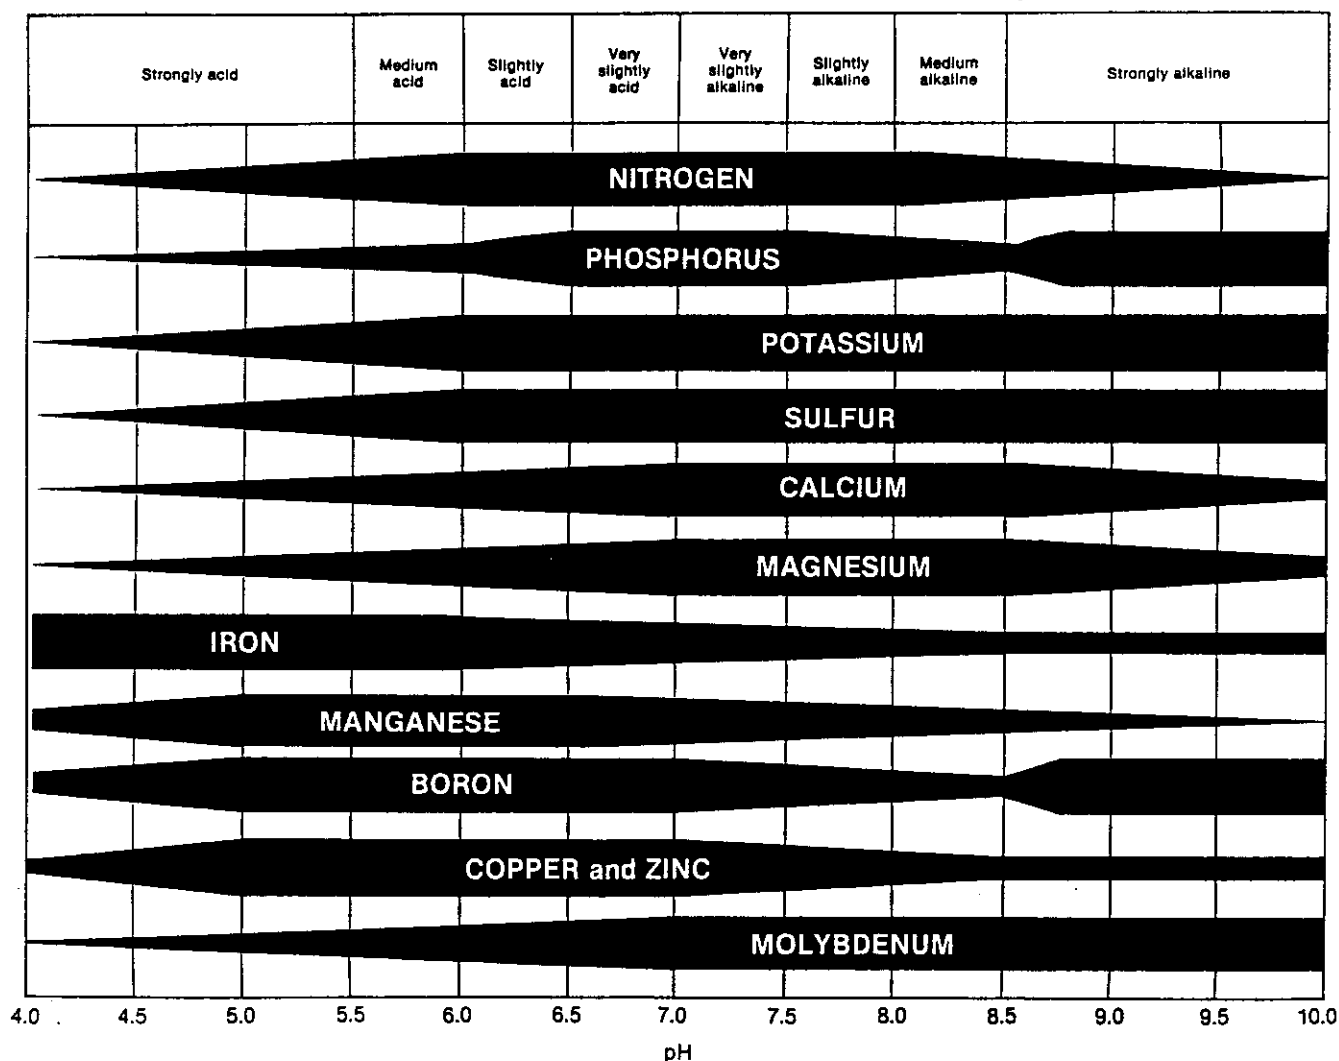
THE pH SCALE

The pH scale is employed to designate the degree of acidity or of alkalinity of the soil. Tests will indicate what type of soil you have. To decrease the acidity one point—say from pH 5.0 to pH 6.0, or from 5.5 to 6.5, apply 75 pounds of agricultural lime per 1000 square feet; or up to double that amount on heavy clay soils. To increase the acidity one point—from 7.0 to 6.0, apply 50 pounds of aluminum sulfate or 20 pounds of sulfur. Most lawn grasses thrive in a slightly acid soil—pH 6.0 to pH 6.5.

Relationship between pH and nutrient availability

The pH scale is employed to designate the degree of acidity or of alkalinity of the soil. Tests will indicate what type of soil you have. To decrease the acidity one point—say from pH 5.0 to pH 6.0, or from 5.5 to 6.5, apply 75 pounds of agricultural lime per 1000 square feet; or up to double that amount on heavy clay soils. To increase the acidity one point—from 7.0 to 6.0, apply 50 pounds of aluminum sulfate or 20 pounds of sulfur. Most lawn grasses thrive in a slightly acid soil—pH 6.0 to pH 6.5.

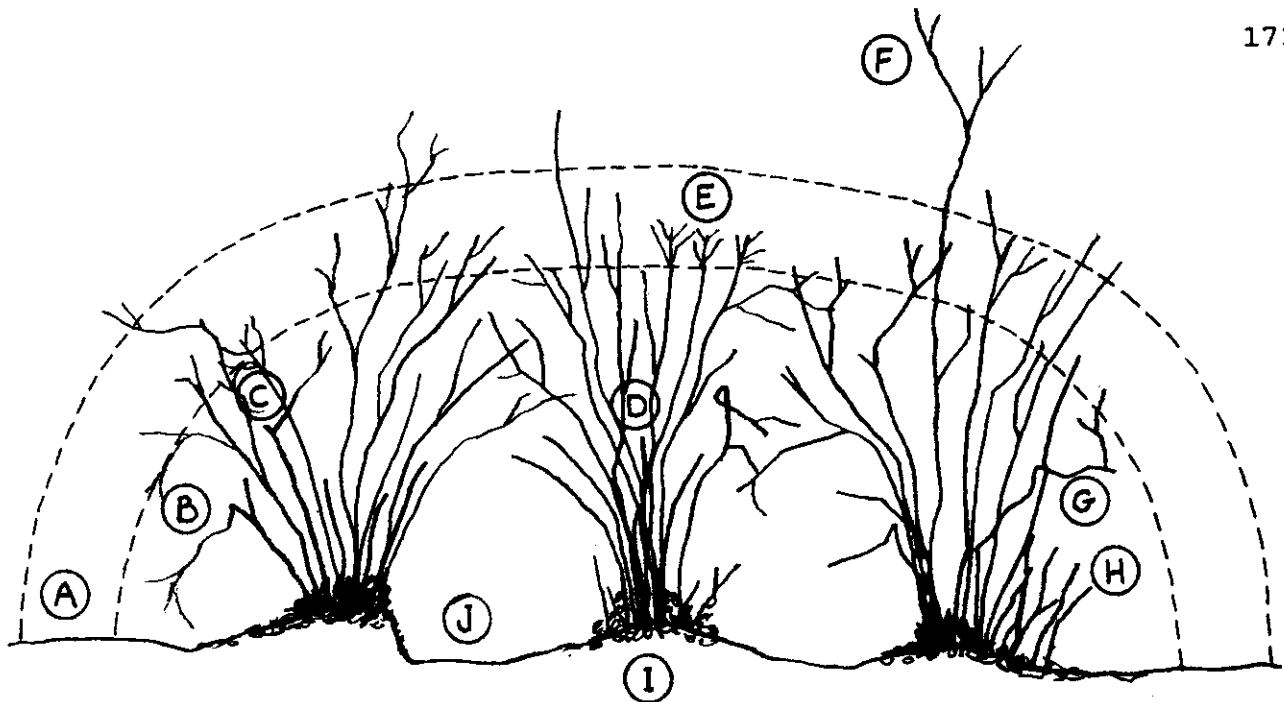
PRUNING GUIDELINES

...CONCERNS — Solutions

- ①... APPEARANCE ZONE (AZ) OF VEGETATION GROUPS:
— Allow stems to develop varied lengths within this area
- ②... BROKEN BRANCHES
— Cut minor stems back to main branch where new growth is possible
- ③... INWARD CROSSING BRANCH
— Prune so top bud faces outward
- ④... OLD DEAD CUT BRANCH
— Remove to ground
- ⑤... SHEARED BRANCHES (ALL CUTS SAME HEIGHT)
— Prune shrubs at various heights
- ⑥... BRANCH OUTSIDE APPEARANCE ZONE (AZ)
— Prune back in balance within AZ
- ⑦... DEFORMED BRANCH
— Usually cut to ground - if minor, may be able to cut back to lateral
- ⑧... NEW GROWTH (STEMS & SUCKERS) OUTSIDE SHRUB BASE
— Prune out, open up interior of base to promote new stems within base
- ⑨... BASE CLUTTER & DEBRIS BUILD-UP
— Clean out debris and old wood to allow for space and light
- ⑩... EXPOSED SHRUB ROOT BASE
— Clean out debris and backfill with top soil

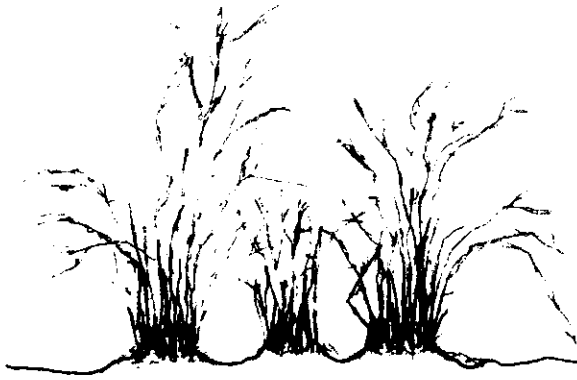
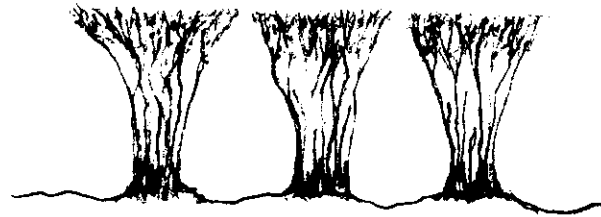
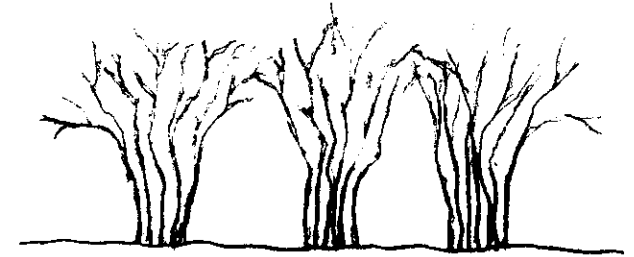
— SHRUB PRUNING APPEARANCE —

NOT THIS

FROM THIS

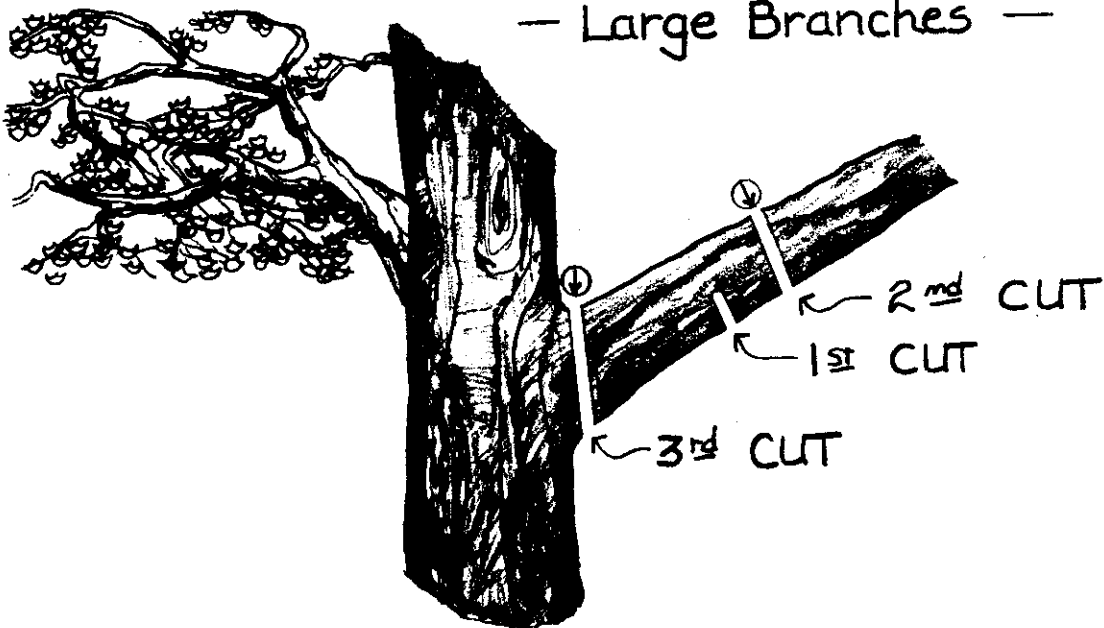
— Large Branches —

Improper
Cuts

① = CUT DIRECTION

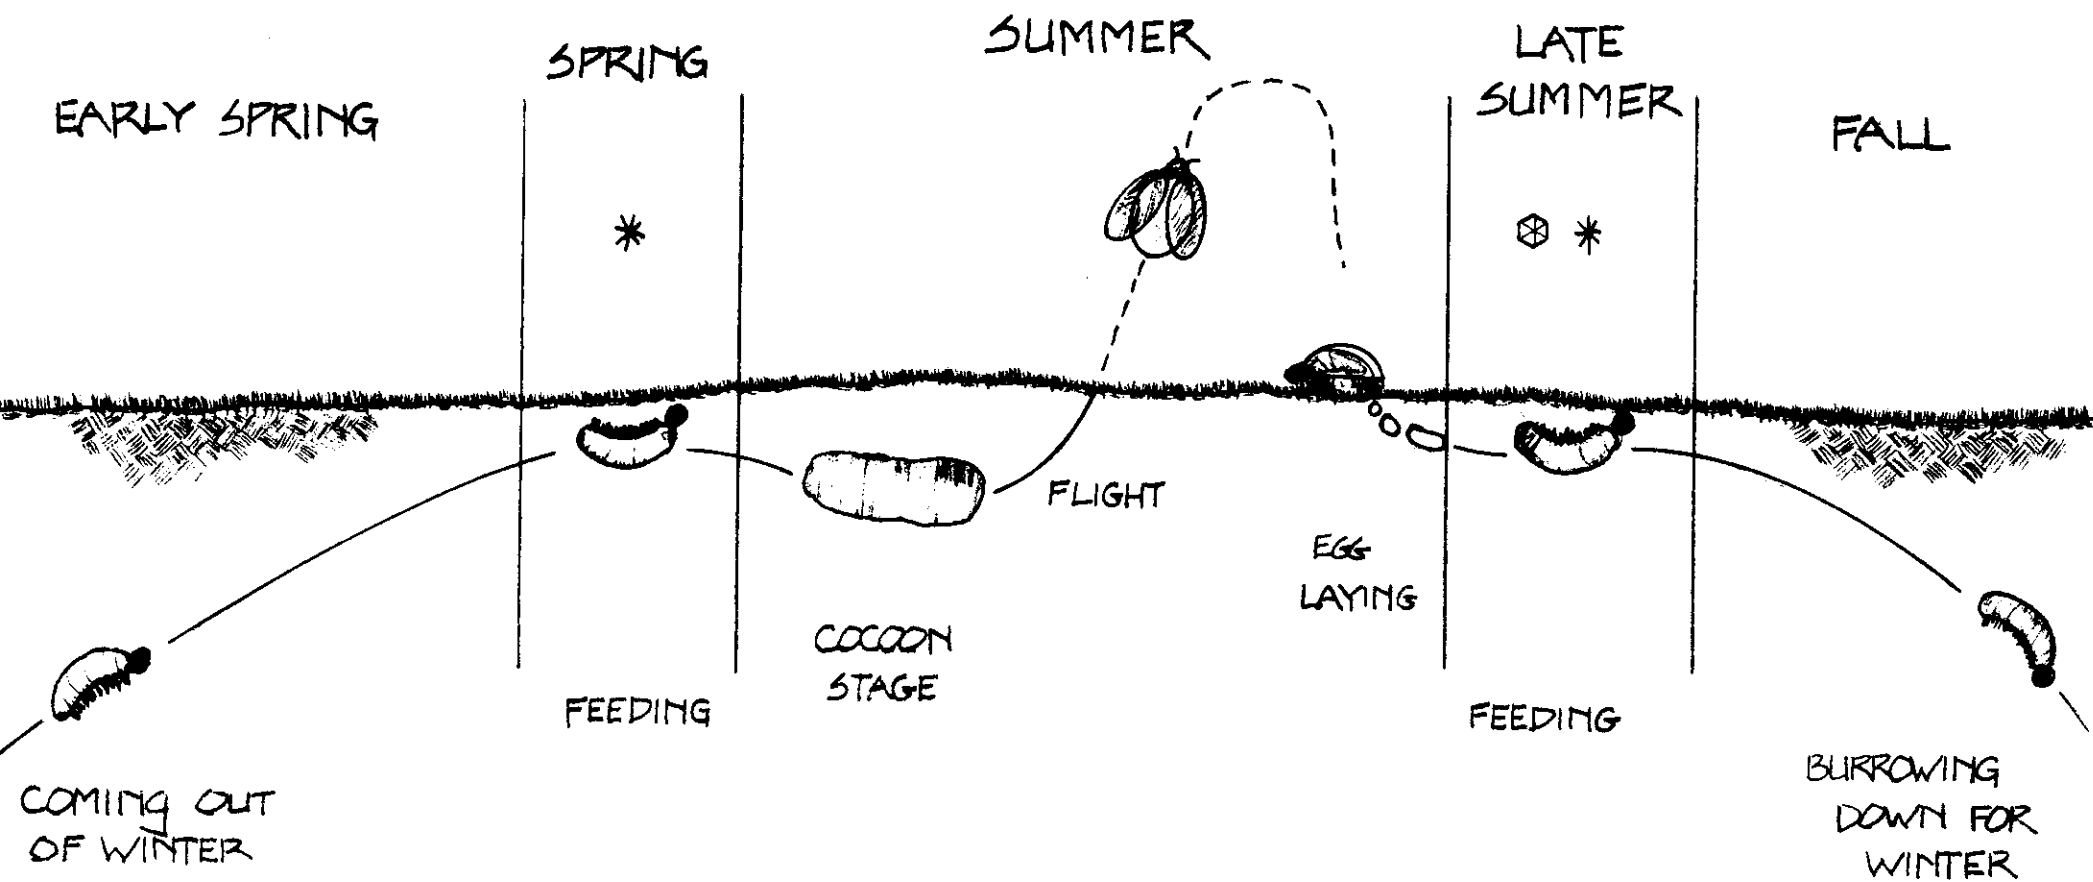
WHITE GRUB CYCLE

* - SUSCEPTIBLE TO CONTROL
 ⊠ - BEST TIME TO CONTROL

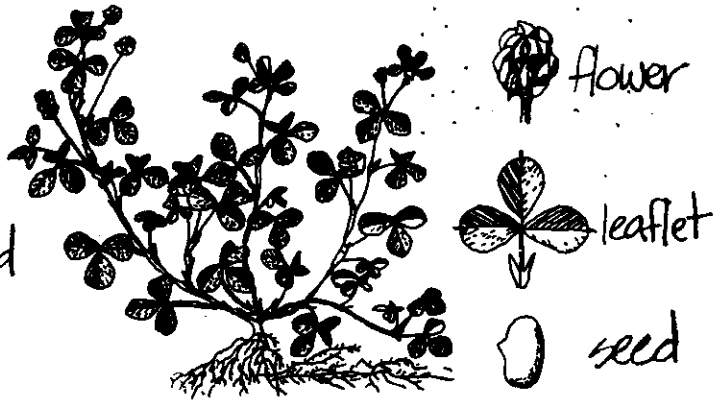
Black medic

- looks like clover—dark green annual—spreading square stems—small tooth at leaflet tip—yellow flower matures into black seed pod

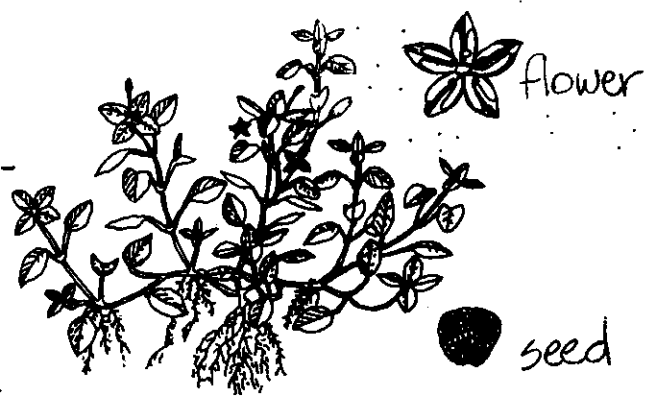
- Mouse-ear chickweed
 — prostrate growth perennial,
 likes full sun — leaves opposite,
 oblong, dark green with soft
 hairs — flowers small, white,
 five petaled.

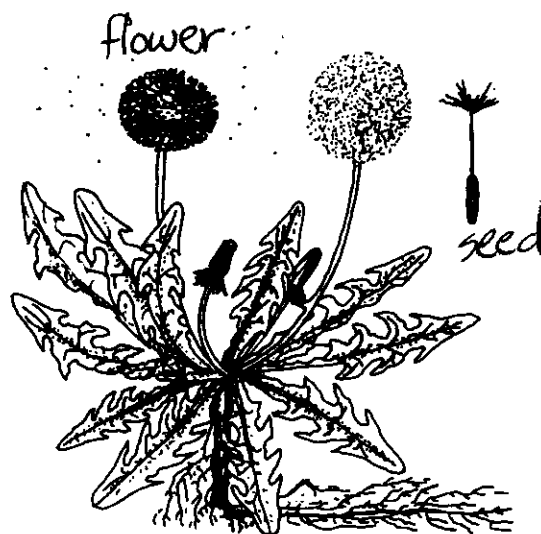
Dandelion

- hardy perennial with strong tap root — long narrow leaves are lobed or serrated — yellow blossom matures into white puffballs full of seeds.

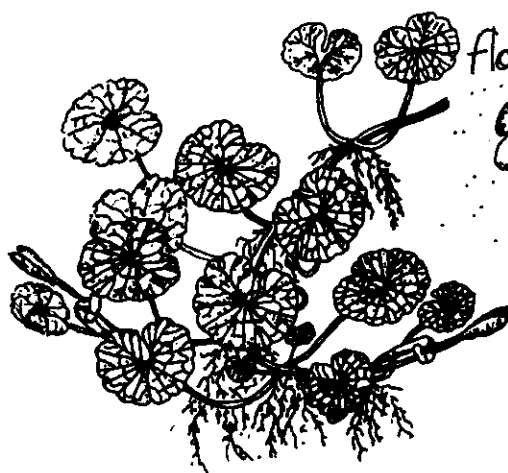
- Ground ivy — creeping, spreading perennial found in shade and sun — leaves round, scalloped on edge, heavily veined, opposite on long, trailing square stems — flowers purplish-blue and trumpet shaped.

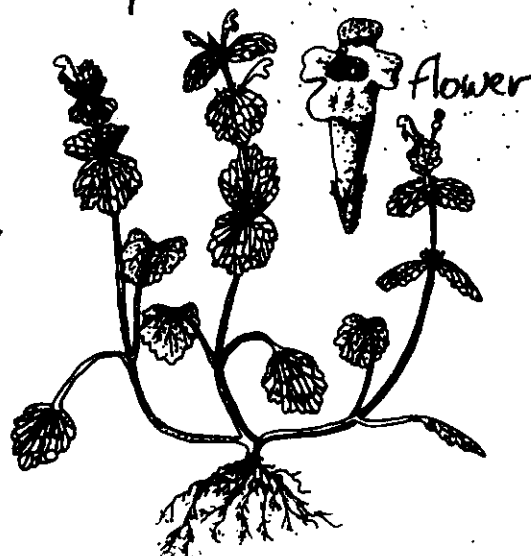
Henbit

- an upright growing annual — leaves rounded, coarsely toothed, hairy, deeply veined, and opposite on square-shaped stem — flowers trumpet-shaped, pale purple.

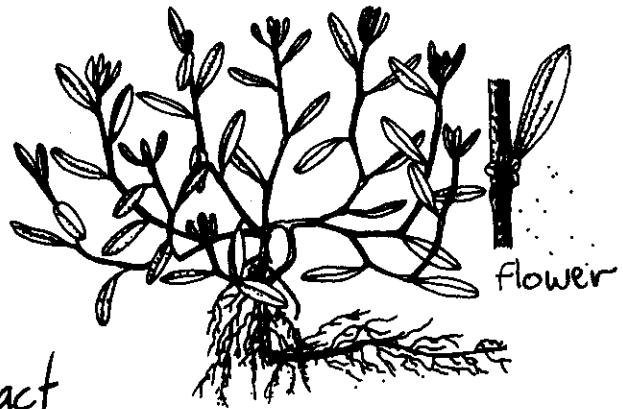
Knotweed

— a tough, wiry prostrate annual — leaves are blue-green, about one inch long with narrow base and rounded tip — flowers tiny, white and found at junction of leaf and stem — likes compact soil.

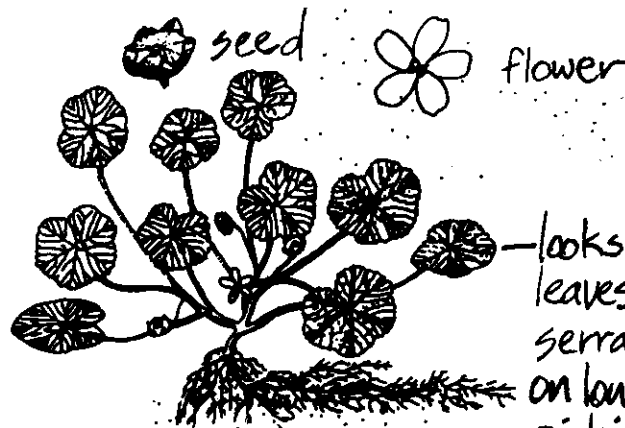
Mallow

— looks like ground ivy — leaves are round with serrated edges and found on long stems — flowers pinkish-white petals and arise from junction of leaf stem and main stem — seeds look like a miniature wheel of cheese.

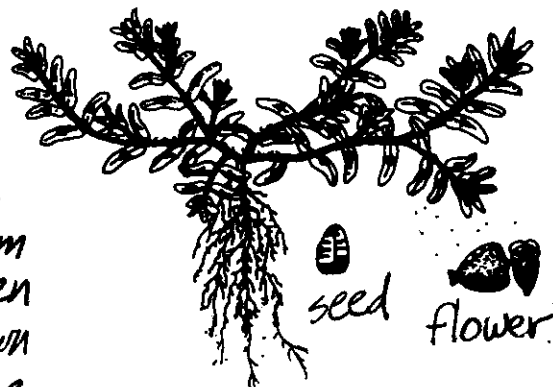
Spotted spurge
 — an annual with leaves up to three-quarters of an inch long — stems expose a milk-like substance when broken — flowers tiny, pinkish-white — leaf colors varies from reddish-green to dark-green with usually a purplish-brown splotch on the upper surface.

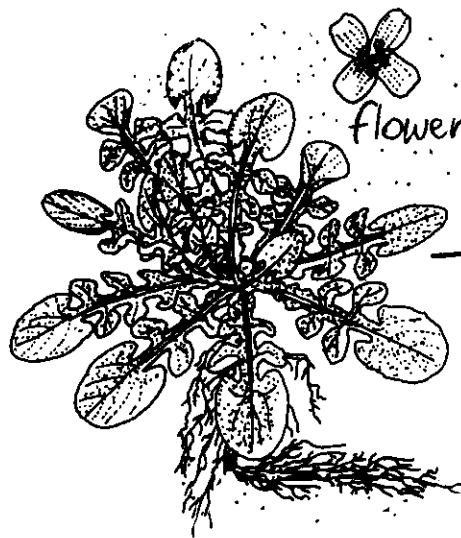
Yellow rocket
—a perennial with bright, shiny green, deeply notched leaves with a large, rounded lobe on the end — flowers are small, yellow, have four petals and are found in clusters at the tips of the uppermost branches.

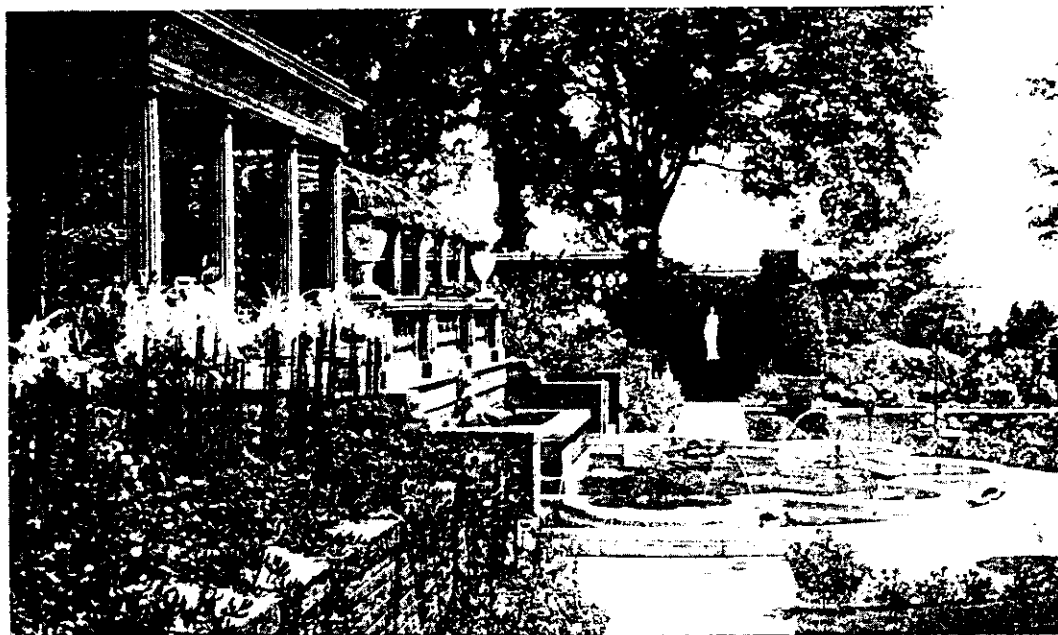
The Pergola

A Massachusetts garden, showing typical uses of Columns, Pergolas,
Balustrade and Art Stone Garden Features

ALL round columns are the well known "Koll-Patent" Lock-Joint Wood Columns, built with due regard to the architectural proportions of the designs they represent, they are provided with Cast Iron Plinths and iron rods to anchor the columns to the foundation. Tops of columns are flashed with galvanized iron.

FOUNDATIONS: The most satisfactory form of foundations for pergolas is concrete piers, but should it not be found convenient to put in concrete piers, a quite satisfactory form of foundation can be had by using cedar posts placed into the ground below the frost line and extending two feet into the columns. (See cut below.) The cost of cedar posts required is included in our price, and will be furnished in place of the iron rods, which are not needed with this form of foundation.

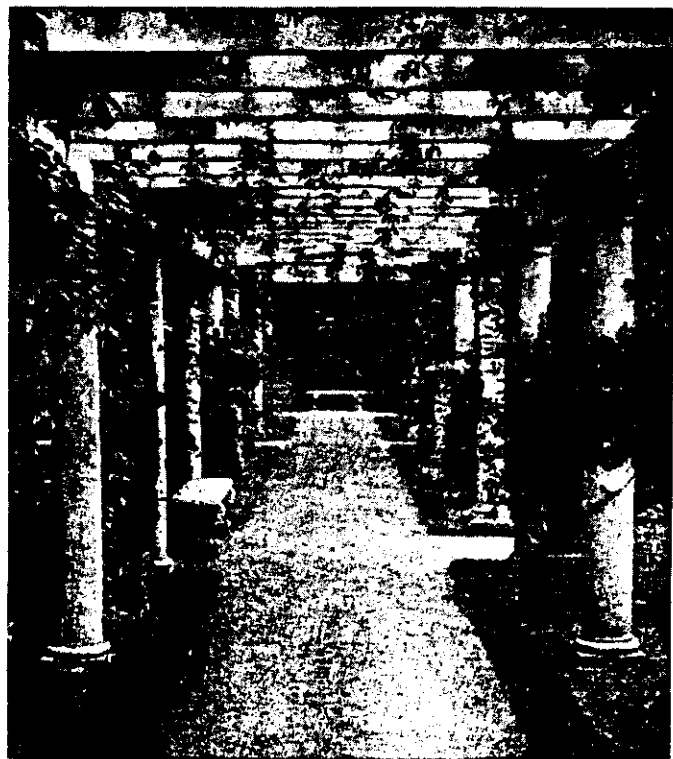
Pergola of "Standard Design"
Size, 8 ft. x 48 ft. Price \$360.00

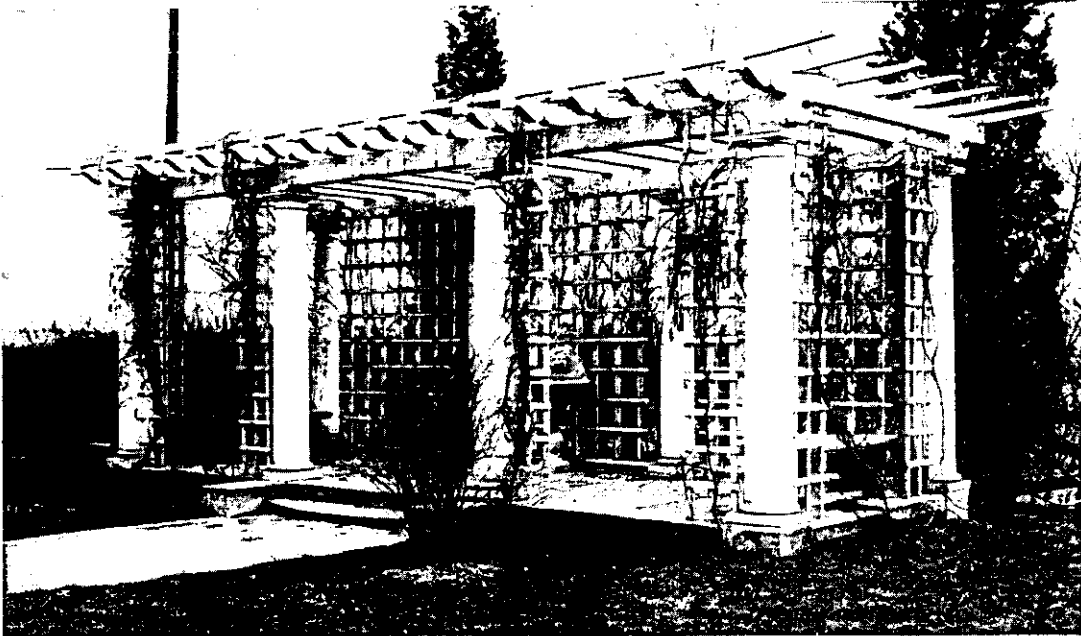
Pergola at Wheaton, Ill. Size, 8 ft. x 24 ft. Price, \$325.00
 Same design, without the Lattice Panels. Price, \$270.00

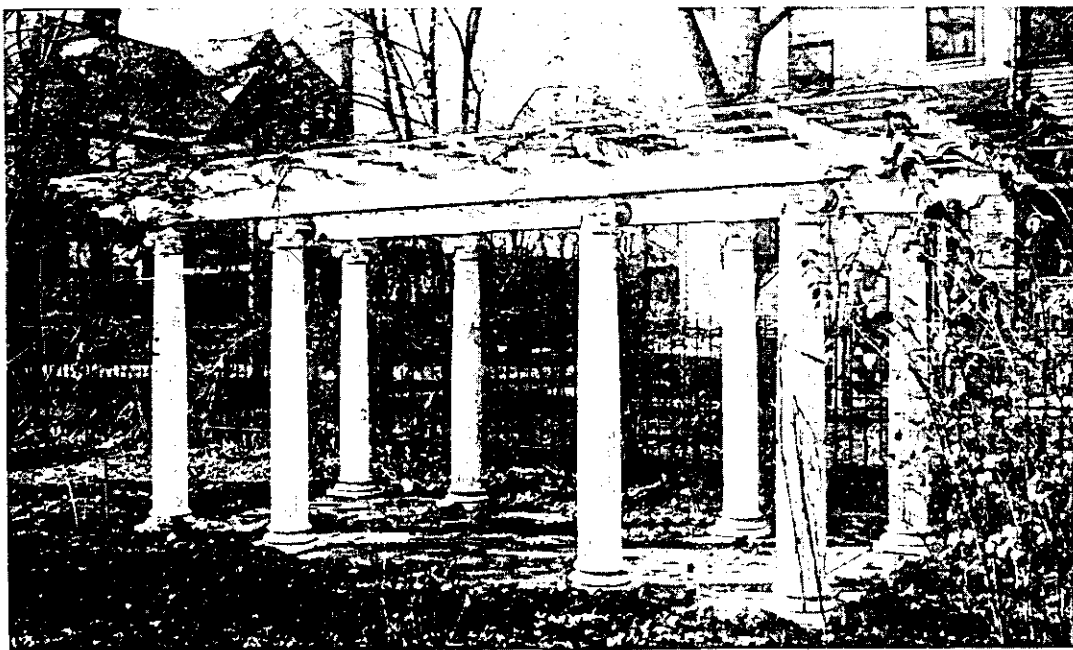
Pergola in Chicago, Ill. Size 7 ft. x 16 ft. Price, \$225.00
 Same Pergola, using Plain Columns as shown on top of this page. Price, \$180.00

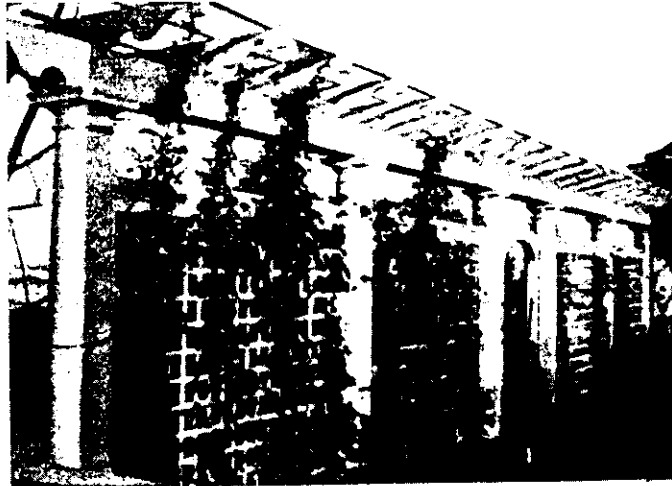
Pergola Lattice Fence at Long Beach, L. I., New York. Fence illustrated is 40 ft. long. Center Section with passage way including Two Columns and Overhead Work, \$62.00. For each additional Section 8 ft. long, with One Column, Lattice Panel and Overhead Work, \$42.00. Same without the Lattice Panels. First Section, with Two Columns and Overhead Work, \$47.00. Each additional Section with One Column and Overhead Work, \$28.00.

Another view showing above Pergola

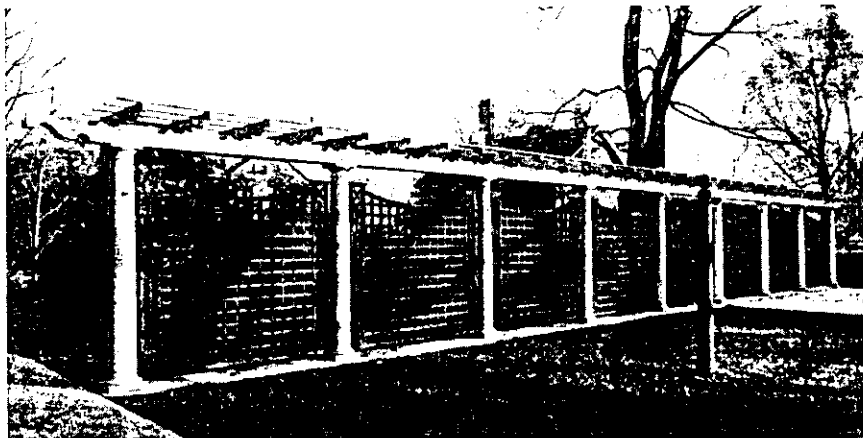
Pergola Lattice Fence, Evanston, Ill. Length over all, 64 ft. First Section, 8 ft. long, including Two Columns, Lattice Panels, and Overhead Work. Price, \$50.00. Each additional Section, with One Column, Lattice Panel and Overhead Work. Price, \$50.00.

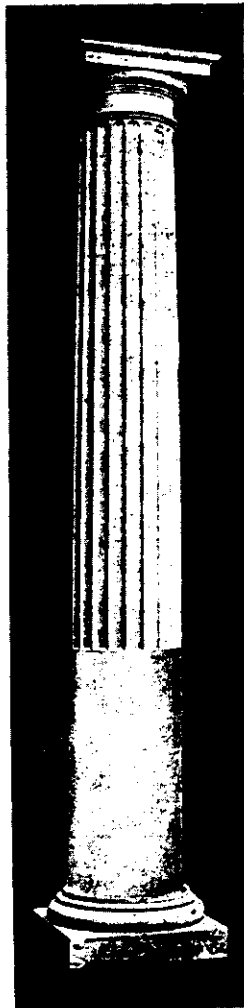
No. 215-2, 3
Roman Doric Column
Fluted upper 2, 3

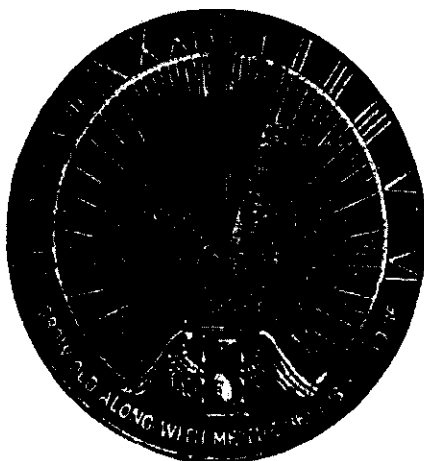
Cast Bronze Sundial, No. 35
11 inches diameter, with raised figures and motto. Weight
of Dial complete, 6 lbs. Price \$9.00

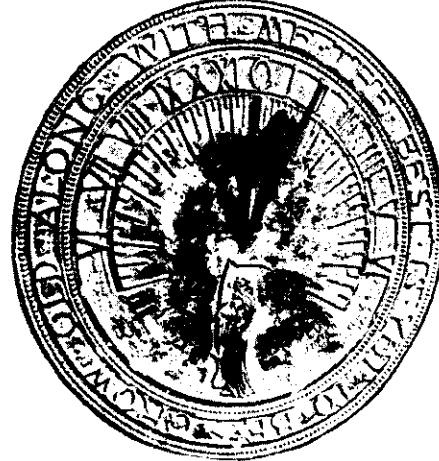
Cast Bronze Sundial, No. 39
 14 1/4 inches diameter, with raised figures and motto.
 Weight of Dial complete, 10 1/2 lbs. Price..... \$21.00
